*Proceedings of the Society
of Architectural Historians,
Australia and New Zealand
30, Open*

Opening the Archive

The New South Wales Forensic Photography Archive as Evidence of Architectural History

Jennifer Preston

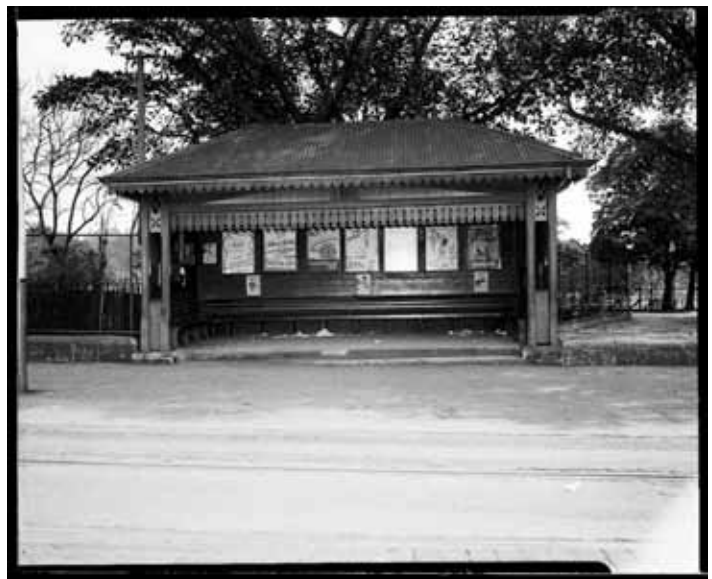
Figure 1. Site of Assault. Tram shelter on City Road. Details unknown.

The first image is of a tram shelter which was located on City Road at the edge of Victoria Park near Sydney University. This could almost be the photograph of an architectural photographer: black and white, dramatic, clearly showing the architectural detail of the timber fretwork, corrugated iron roof and the skilled work of the carpenter's timber seat. Like many architectural photographs there are no people. Only the collection of posters on the rear wall, the handbills pasted on the backrest of the seat and the rubbish accumulated around the floor of the shelter tells us this has been a recently inhabited space. The tram lines in the foreground promise it will be inhabited again, indeed removed from its criminal context as the site of an assault one might think that the photographer had just missed the tram.

This photograph is, I believe, in terms of public space architecture an important one, because while much has been written on the rolling stock of Sydney's tramway system, the various routes, the track infrastructure and the people who operated it there has been almost no attention paid to the built form that it generated.²¹ This built form in its day was extensive; tram sheds, carriage works and tram stop shelters, but it was utilitarian and did not attract the fascination of the transport technology it facilitated. There are other photographs that show tram shelters but they are usually in the context of a more general street scene or as a backdrop to another photographic subject. This image is a portrait of the tram shelter itself, the design suggesting it was built in the early days of the electric trams in Sydney, the first decade of the twentieth century.

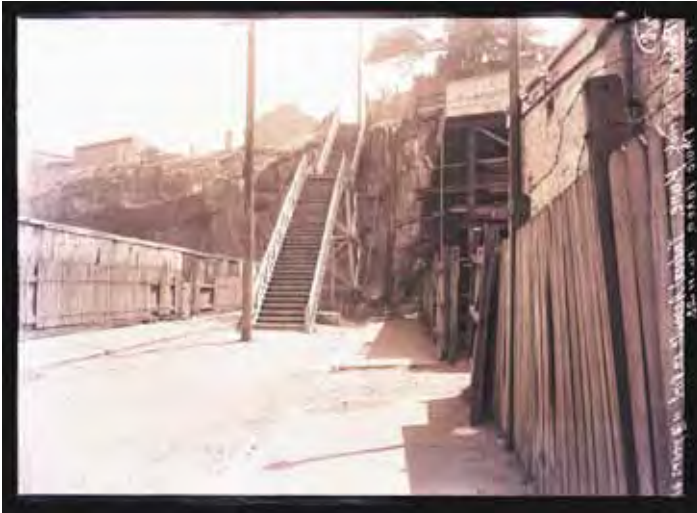
Figure 2: Indecent assault on girl 11 10/12 years, November 14, 1923. Mount Street, Pyrmont at the corner of Miller Street.

Now we move to another element of utilitarian built form in the public space of the city and another assault. Whilst for a moment in November 1923 this public stairway was the site of an indecent assault on a girl who may have been as young as 10, this is only one tragic incident in the history of this stairway which was also the site of accidental falls some resulting in death.

This stairway has undergone many transformations. The first version was a timber stairway built in 1887 to a design signed off by R. W. Richards the City Surveyor.²² This first version of the stairway did not last long, and in 1899 a specification was produced by the Sydney City Council “for the Removal and Re Erection of wooden Steps [sic]” in the same location and a drawing again signed by R. W. Richards was produced. The drawing from the City of Sydney archives shows the timber structure of the stairway with a picket style fence on the outside of a cross braced balustrade.²³ In 1903 the stairs were repainted at a cost of twelve pounds and twelve shillings, work that the city building surveyor claimed was “badly needed.”²⁴ In 1914 the timber support trestles and stringers were replaced with iron although the design of the steps and balustrade remained similar. This is the version of the stairway we see in the Forensic Photography archive photograph from 1923.

Apparently neither Robert Saunders nor Albert Sampson were successful with their requests. In 1931 the stair was reconstructed yet again but this time with a structure in mild steel with galvanised iron pipe handrail and a wire mesh balustrade. The steps themselves had hardwood treads and open risers and were fixed to the stringers with steel angles.²⁷

A stairway still exists in this location today, it still has timber treads and open risers with a metal mesh balustrade but today there is a change in direction at the landing so that a hapless pedestrian cannot fall in a straight line all the way from the top. A stair is not a benign component of architectural form. Stairways have been described by the American architect John Templer as "one of the world's most dangerous products."²⁸ Whilst Templer was referring to the stairway as a site of trip hazards and accidental falls, the Forensic Photography Collection illustrates flights of stairs as places not only of accidents but that also have a criminal past as the sites of assault, indecent exposure and murder.

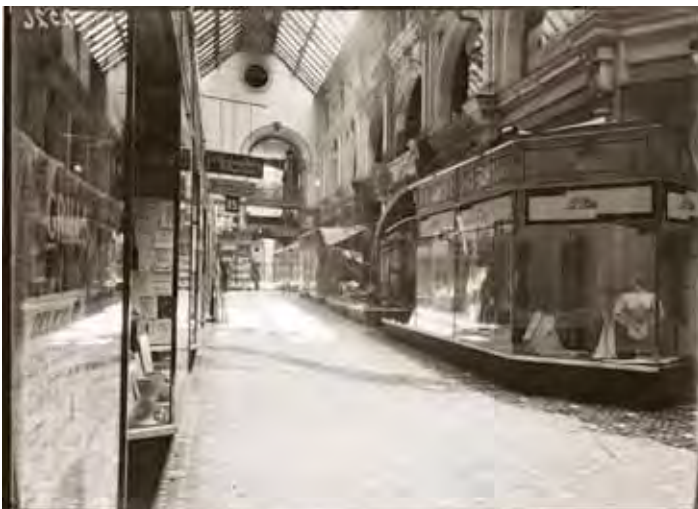
Figure 3. The aftermath of a shopfront fire in the Sydney Arcade around 1937. Details unknown.

The roof structure of the building was wrought iron, with clearstory windows for the full length of both sides of the arcade. These were mechanically openable for ventilation. The floor was finished in encaustic tiles and the arcade was lit with electric lamps.³¹ The electric lighting was such a new phenomenon that it was considered an attraction at the promenade concerts held in the arcade by the proprietors.³² The Gibbs, Shallard & Co. *Illustrated Guide to Sydney* for 1882 described the arcade as “an elegant bazaar” and “a popular promenade.”³³

The fire that resulted in the photograph from the Forensic Archive is possibly that from January, 1939 which reportedly took fifty firemen from six brigades to extinguish and caused fifteen thousand pounds worth of damage.³⁴

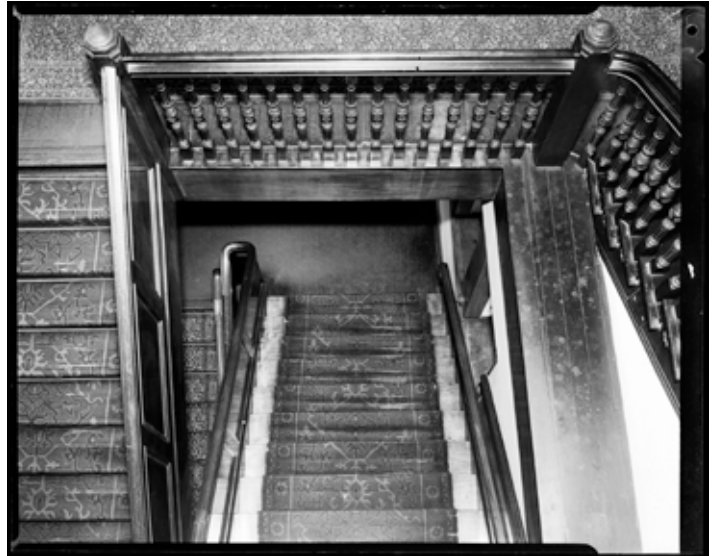
Figure 4: Scene of Death, Hotel Metro-
pole, Sydney City, August 15, 1955.

However this image of its stairway is from the Forensic Photography Archive. The stairway was twenty eight feet by twenty seven feet with the "newels, balusters and handrail ... hand-somely carved in blackwood" and with the soffit of the stair "panelled and moulded with selected cedar." I have found no record in newspapers of the death in 1955 for which the photograph was taken but the Hotel Metropole could be a dangerous place. In one week in 1954 three men died in separate incidents there by falling, two by falling down a lift shaft, both on separate occasions and one by falling out a window.

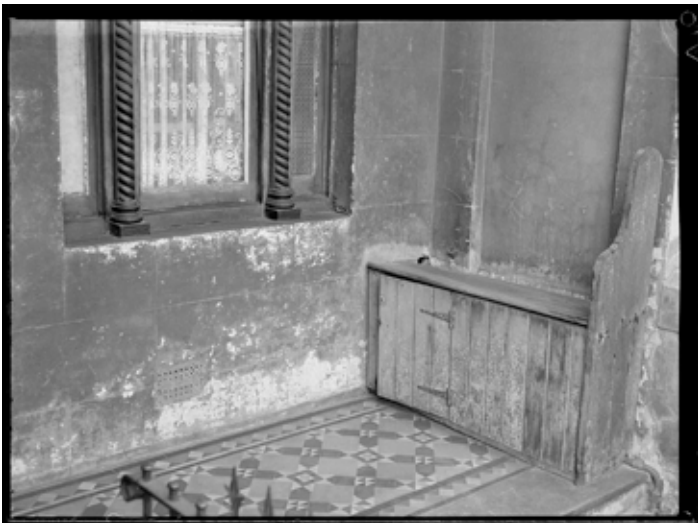
Figure 5. Exterior detail of house in Great Buckingham Street.

The series of photographs relating to the Mrs Grills case show a domestic space of the 1950s. Not the idealised, modern, clean spaces an issue of *Australian House and Garden Magazine* at the time but everyday domestic spaces where newer styles of furniture and appliances sit side by side with older pieces in an overlaying of domestic technology from different times within a terrace house from the late 1800s. There are details of the outside of the terrace, of the tessellated tiles on the verandah, the cast ironwork, the twisted engaged columns of the three part window, a timber bench with storage space below, that possibly houses the gas meter, the worn paintwork of the rendered and coursed façade and a metal ventilation grille.

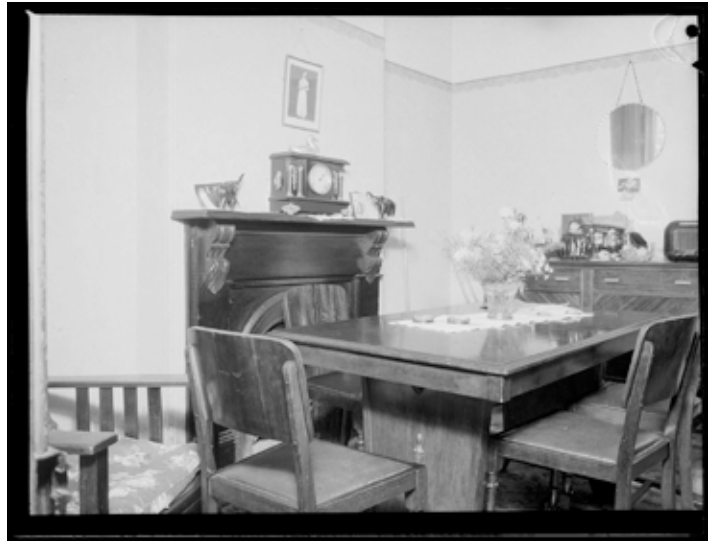
Figure 6. Interior of dining room at a house in Great Buckingham Street.

When the photographer moves inside we are shown a range of the domestic spaces, the lounge, dining room, kitchen and laundry. The dining room contains a Victorian fireplace dating from the time of the buildings construction, but the wallpaper, furniture and Bakelite radio are from a sequence of more recent times.
